# **Appendix H – Summary of Exceedance**

**Contract No. HATS 01/2025**

**Environment Team for Hung Shui Kiu Effluent Polishing Plant – Phase 1**

**- Investigation Report of Water Quality Action/Limit Level Exceedances in June 2026**

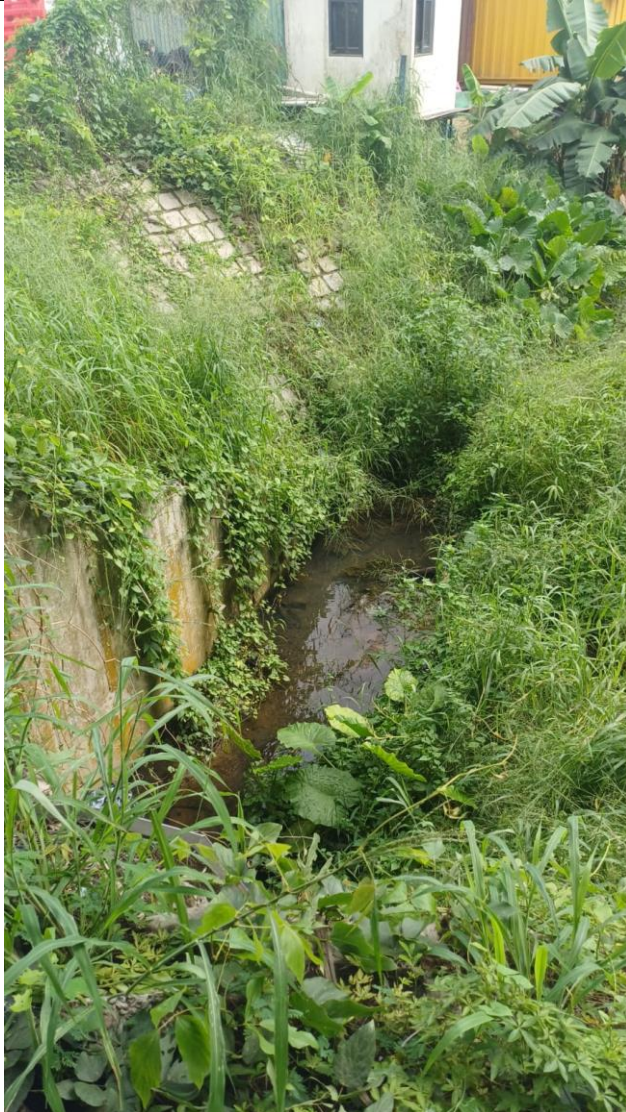
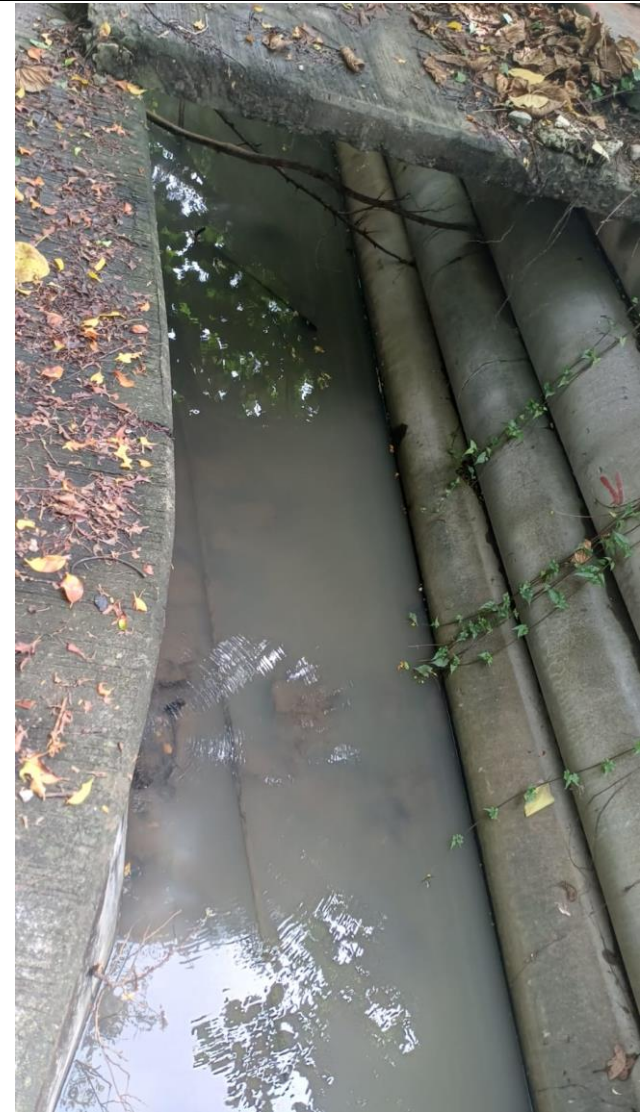
- According to field staff observations, a higher turbidity or muddy water was observed at the monitoring location M1 on 08, 15 and 17 June 2026(See **Photos 1a, 1b, 2a & 2b**). The field staff cannot search for the pollution source due to the limited access to the construction site on those days. However, the ET Auditor observed the abnormal discharges from the pipe placed into the stream from the surrounding CEDD construction site during the weekly site inspection (See **Photos 6 & 7**)
- In addition, high rainfall was recorded surrounding the monitoring day, which may have led to the discharge of a high volume of runoff with topsoil, debris and settled mud from the sub-channel under Kong Sham Western Highway into the stream. (See **Photo 8**)
- No direct evidence that the recent exceedances were due to the construction activities of the Project.

Photo 1a (Taken at C1 Station on 08 June 2026)

Photo 1b (Taken at M1 Station on 08 June 2026)

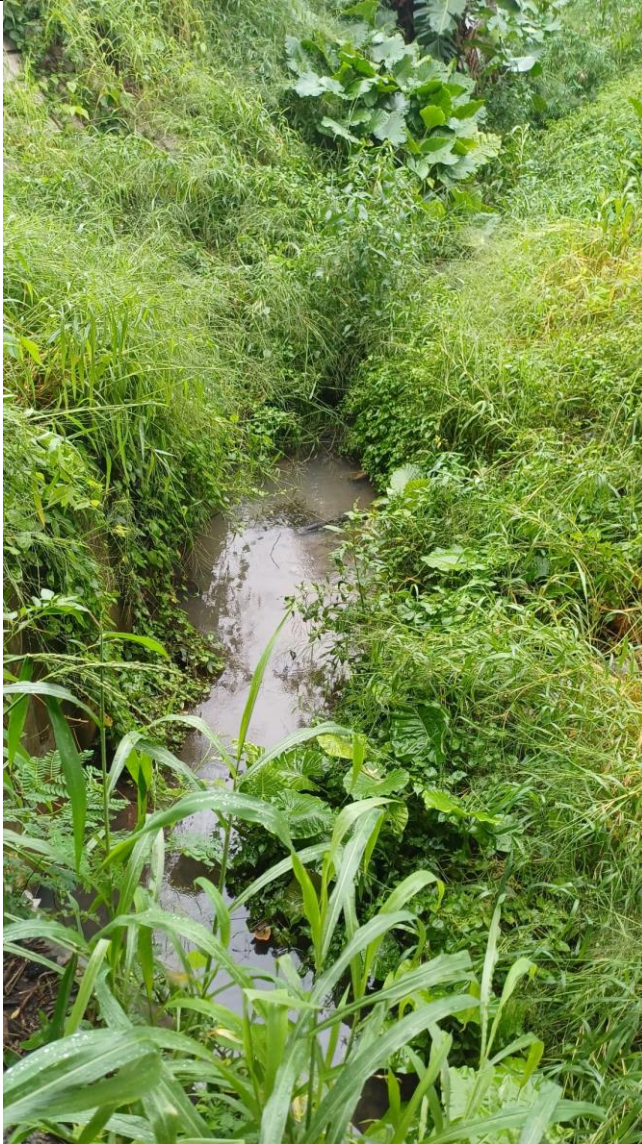
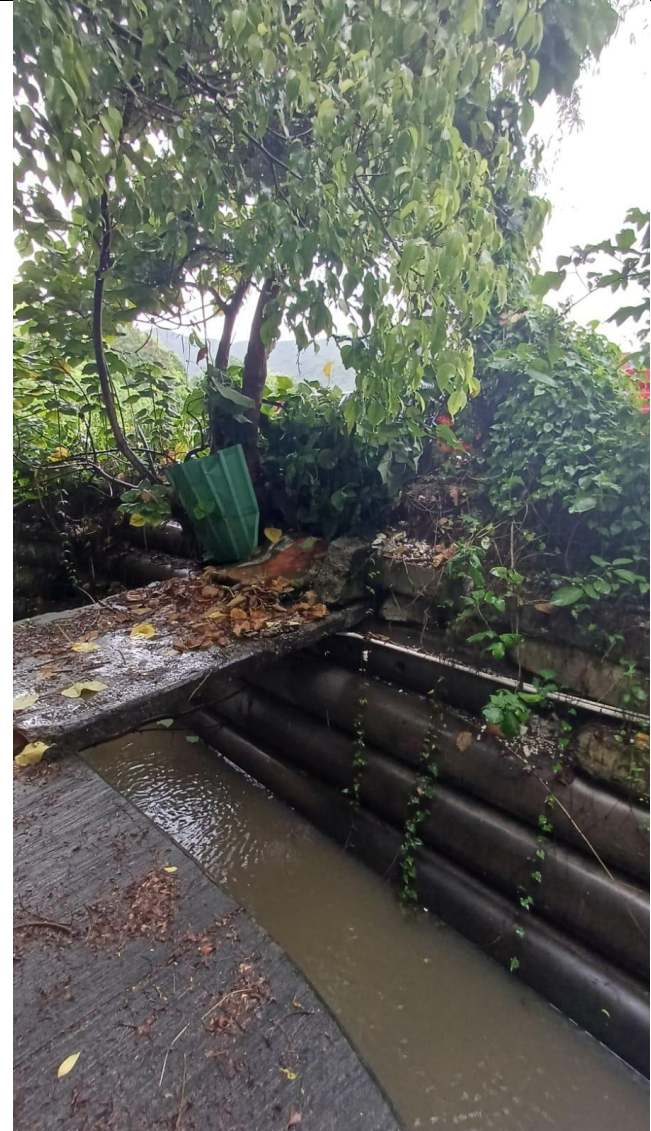
Photo 2a (Taken at C1 Station on 15 June 2026)

Photo 2b (Taken at M1 Station on 15 June 2026)

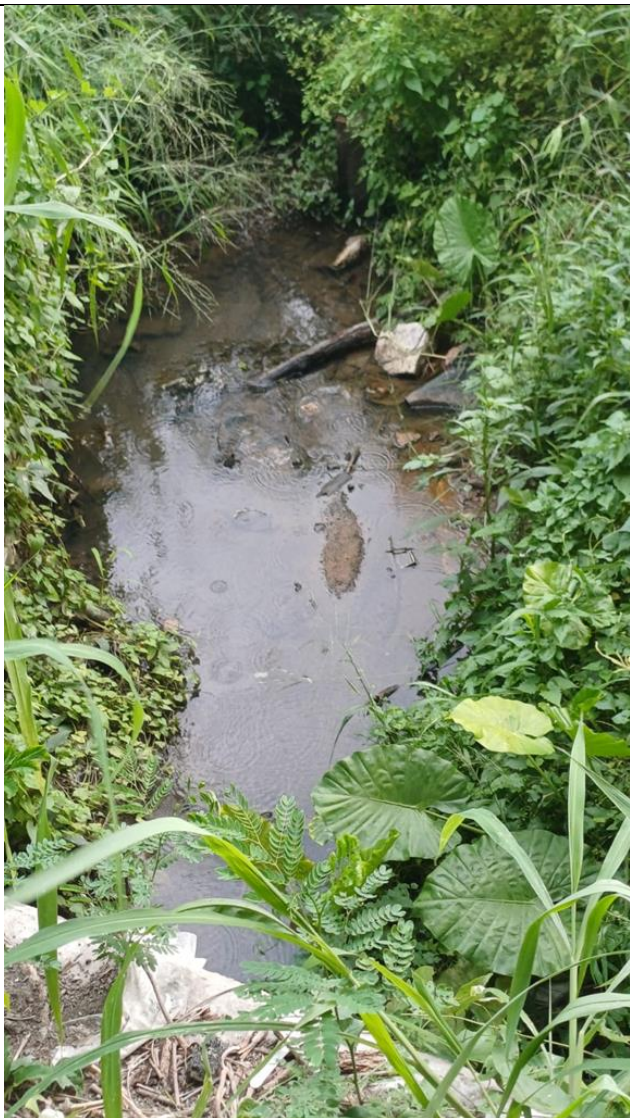
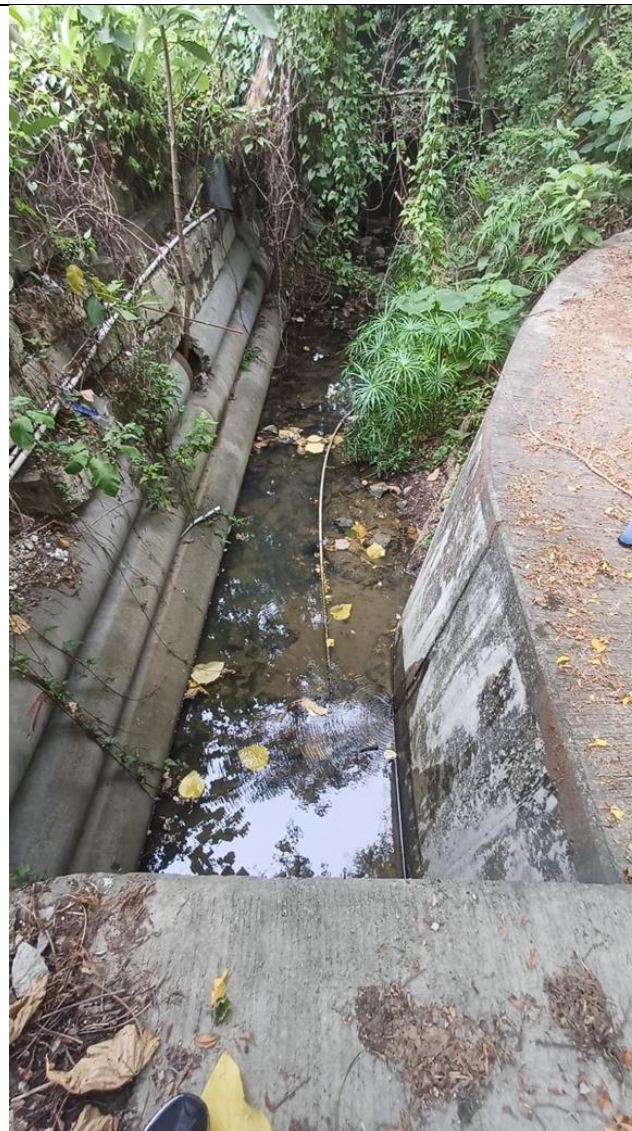
Dissolved Oxygen (DO) level at M1 (Impact Station) exceeded the Limit Level on 05 June 2026 (See **Photos 3a & 3b**). The stream flow from the upstream with sandbags and Geotextile was removed from the CEDD construction area (See **Photo 4**). However, our ET auditor observed several accumulations of debris, mainly plastic foam rubbish that chokes the main stream (See **Photo 5**). In addition, a blockage was observed downstream of C1 near the Kong Sham Western Highway at the CEDD construction site (See **Photos 6 & 7**).

The low stream flow from those issues reduced dissolved oxygen when there was no higher surface runoff from upstream or from the subchannel under the Kong Sam Western Highway due to rainfall. We considered that the low stream flow, due to the usual blocking caused by several debris accumulations and the CEDD contractor's construction arrangements, led to a decrease in dissolved oxygen.

Photo 3a (Taken at C1 Station on 05 June 2026)

Photo 3b (Taken at M1 Station on 05 June 2026)

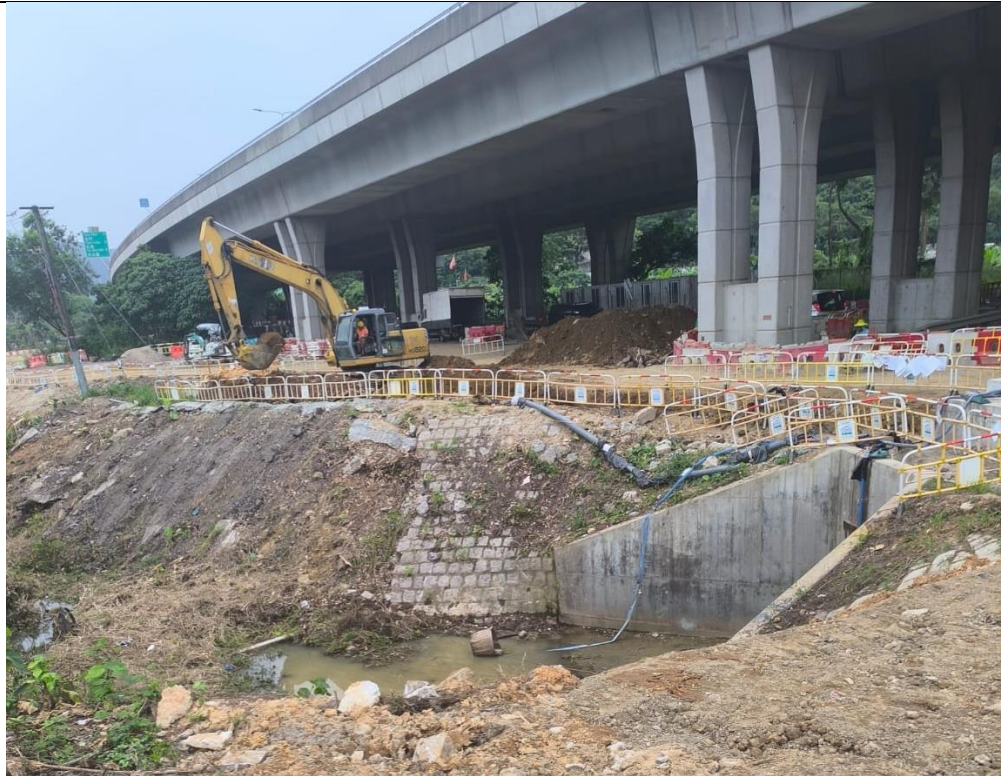
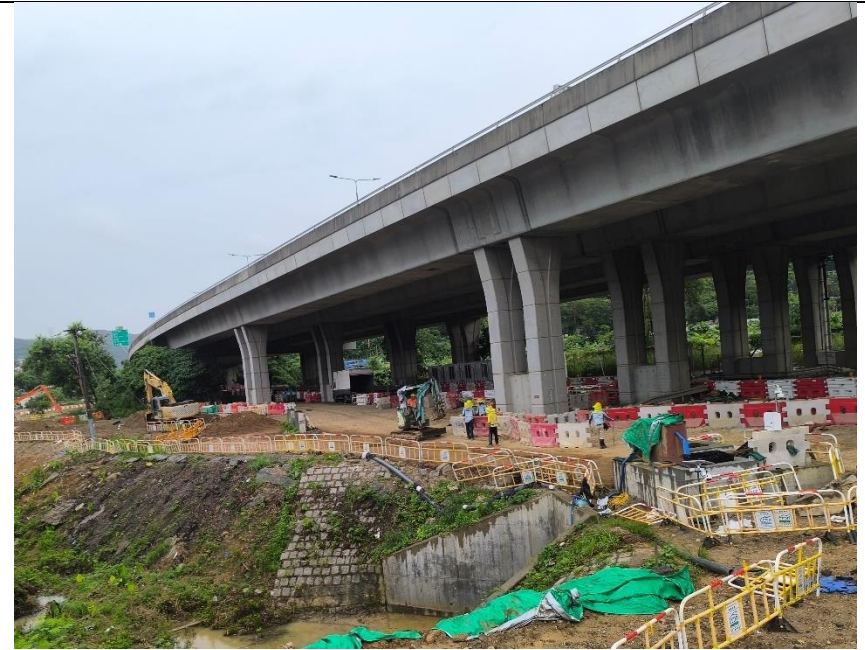
Photo 6 (Taken at the downstream of C1 near Kong Sham Western Highway on 12 June 2026)

Photo 7 (Taken at the downstream of C1 near Kong Sham Western Highway on 26 June 2026)

Remark: We observed that the build-up outfall was blocked, and the blue pipe was set up to pump out the accumulation of muddy water in the well and sediment tank.
