# **Appendix H – Summary of Exceedance**

**Contract No. HATS 01/2025**

**Environment Team for Hung Shui Kiu Effluent Polishing Plant – Phase 1**

**- Investigation Report of Water Quality Action/Limit Level Exceedances in July 2026**

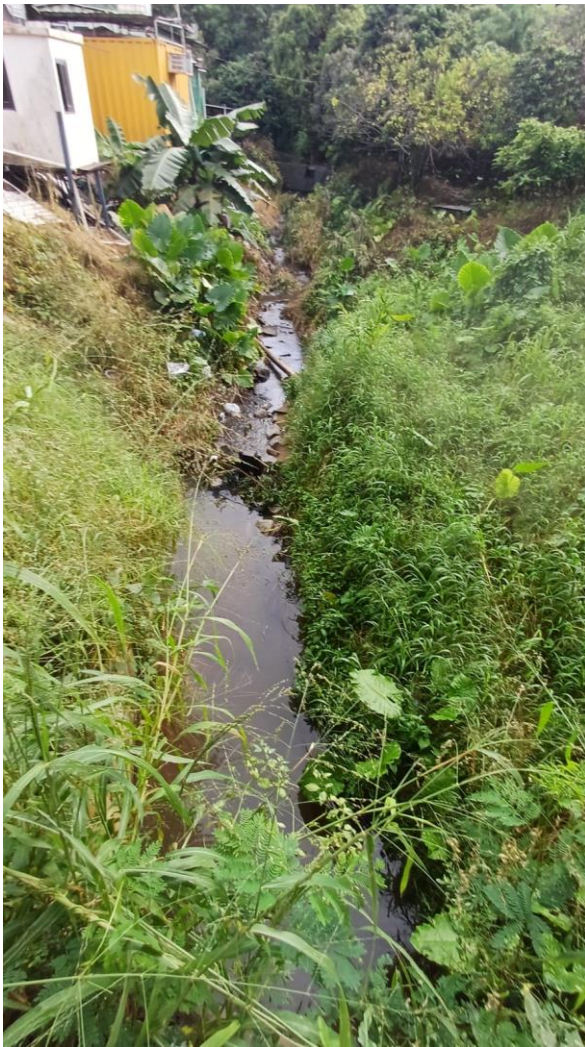
Photo 1a (Taken at C1 Station on 06 July 2026)

- According to field staff observations, a higher turbidity or muddy water was observed on 06 July 2026 at the monitoring location M1 and on 17, 20, 27, 29 and 31 July 2026 at both monitoring locations C1 & M1 (See **Photos 1a, 1b, 2a, 2b, 3a & 3b**). The field staff cannot search for the pollution source because access to the construction site is limited on those days.
- Blockage of the main stream caused by accumulated plastic foam rubbish has been observed since June 2026, which severely impairs natural flushing capacity and increases the time we find muddy water in the stream (See **Photo 4**).

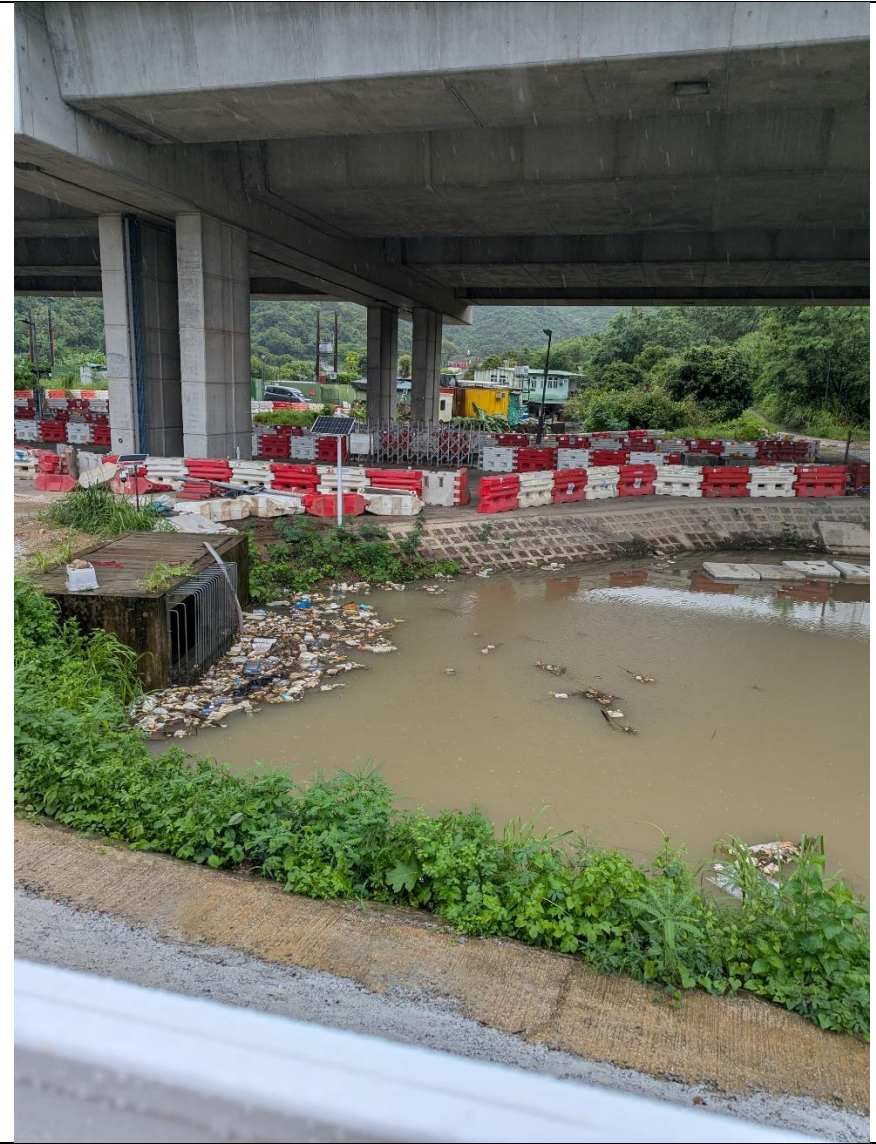
Photo 5 (Taken at the Sub-Channel under Kong Sham Western Highway on 31 July 2026)

- High rainfall was recorded surrounding the monitoring day, which may have led to the discharge of a high volume of runoff with topsoil, debris and settled mud from the sub-channel under Kong Sham Western Highway into the stream (See **Photo 5**). Therefore, the exceedance cases are focused on the day or the day before the recorded high rainfall. (See **Appendix D**)
- No direct evidence that the recent exceedances were due to the construction activities of the Project.

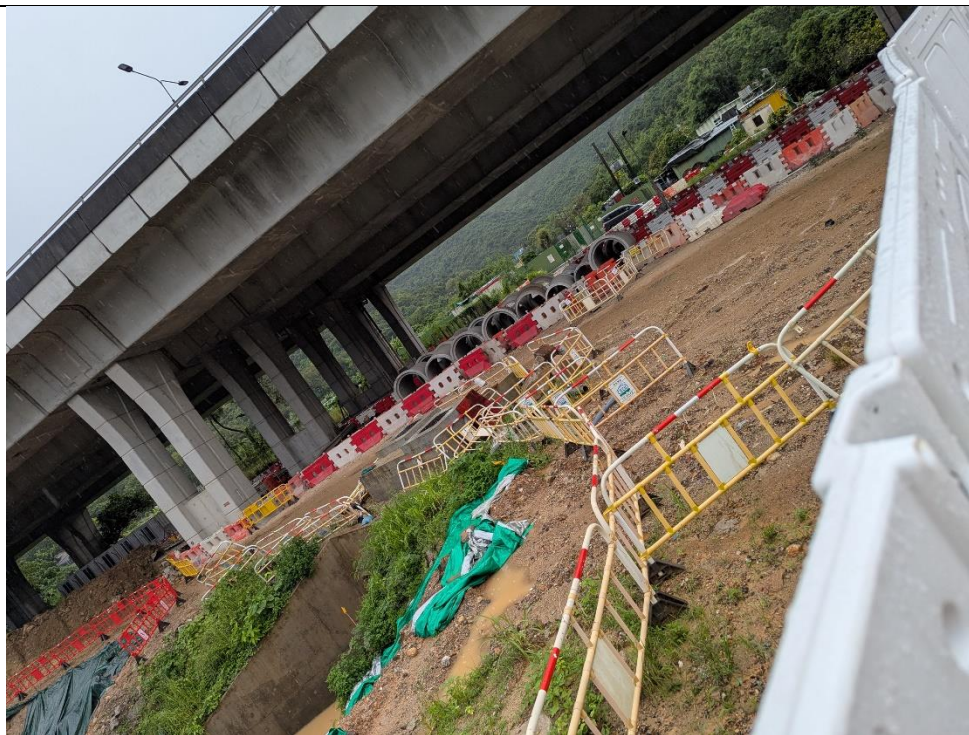
Photo 6 (Taken at the site boundary between the DSD construction site and CEDD construction site on 31 July 2026)

In addition, the DSD construction area is surrounded by the CEDD construction site (see **Photos 6 & 7**). Therefore, we consider that the related pollution should not be in the DSD construction area.

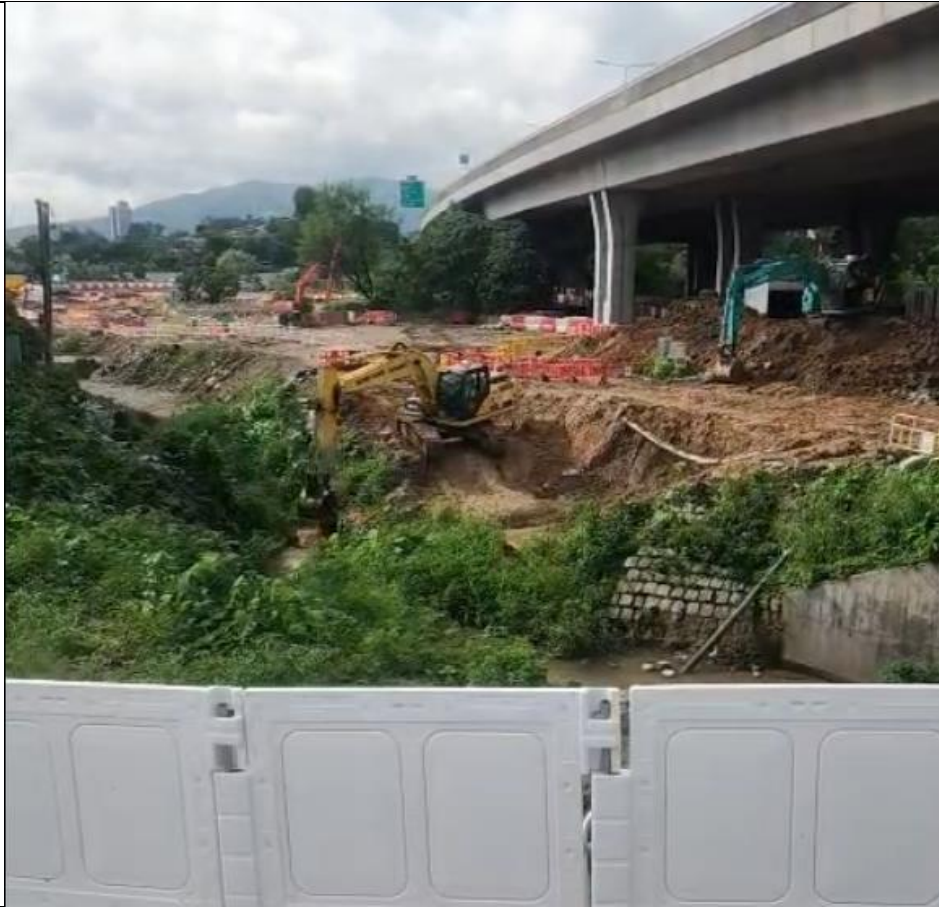
Photo 8 (Taken at the site boundary between the DSD construction site and CEDD construction site on 29 July 2026)

However, the project team member observed that an excavator at the CEDD construction site cleaned the muddy water into the water bodies on 29 July 2026 (See **Photo 8**). In addition, the ET field staff observed the abnormal discharges from the pipe placed into the stream from the surrounding CEDD construction site at the downstream of monitoring location M1 during the water quality monitoring on 13 July 2026 (See **Photo 9**). Since those abnormal discharges are recorded on a non-monitoring day or observed downstream of monitoring location M1, they may not influence the monitoring result at monitoring location M1. The situation of any cause that exceeds water quality monitoring will be continuously monitored by ET, specifically the nearby CEDD construction site.
